WATER OPERATION AND MAINTENANCE

BULLETIN NO. 147

March 1989

CONTENTS
WATER OPERATION AND MAINTENANCE BULLETIN
NO. 147
March 1989

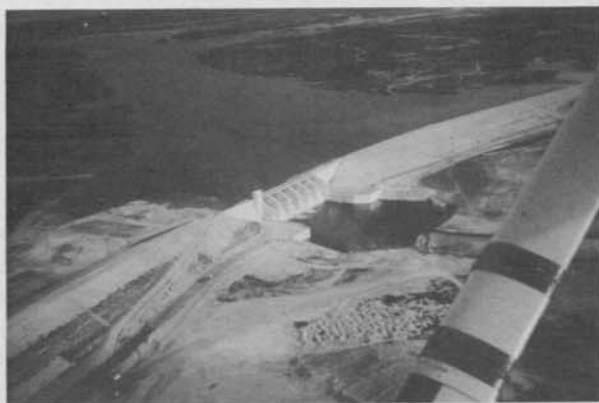
Cover photograph:

Aerial view of Brantley Dam and Reservoir showing maximum section of dam.

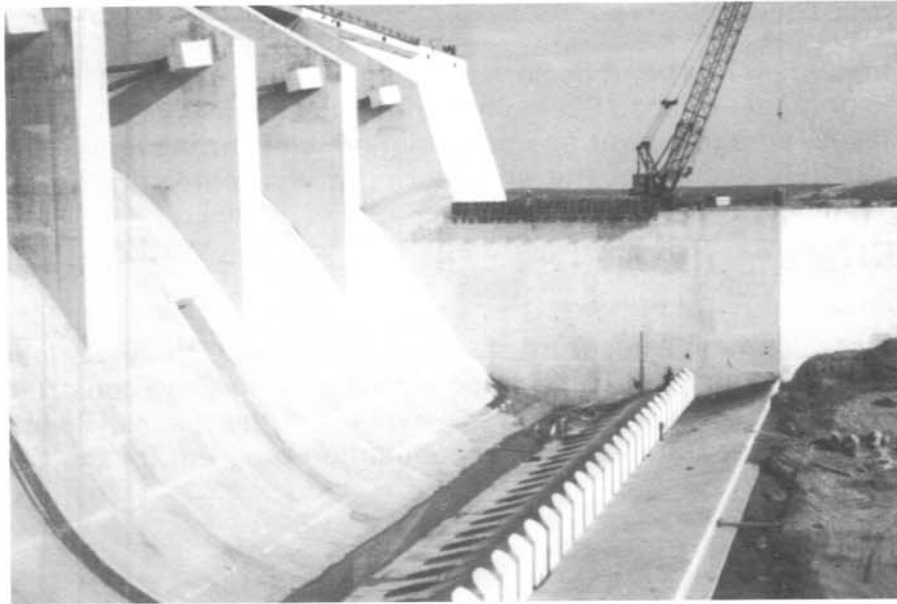
Figure 1. - Brantley Dam - Spillway chute and stilling basin.
10/4/87

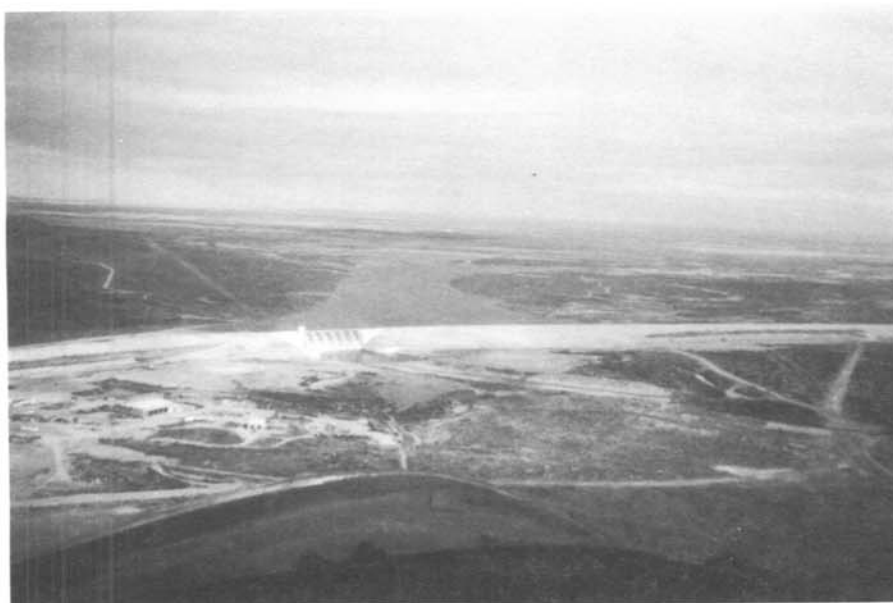
Figure 3. - Brantley Dam and Reservoir showing O&M complex in left foreground. 9/22/88

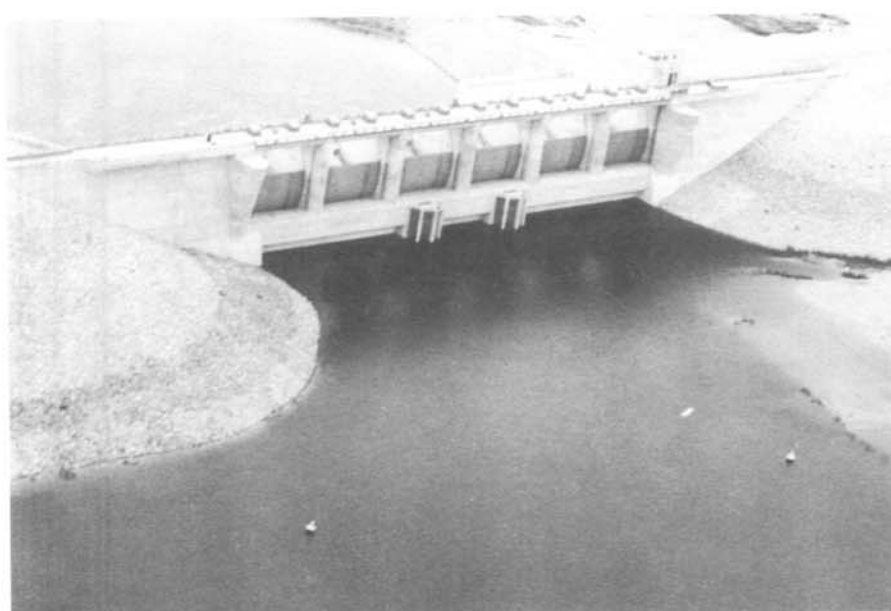
Figure 4. - Brantley Dam - Aerial view of the Reservoir and concrete structure. Note two safety buoys to which a safety float line will be connected between these buoys. 9/20/88

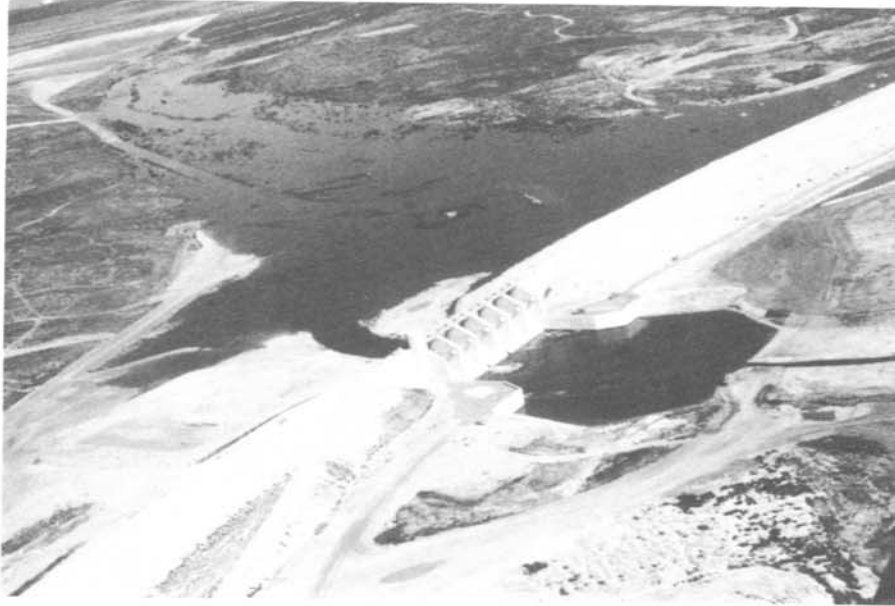
Figure 5. - Brantley Dam - Aerial view of concrete structure, stilling basin, left and right abutments, and Reservoir. 9/7/88

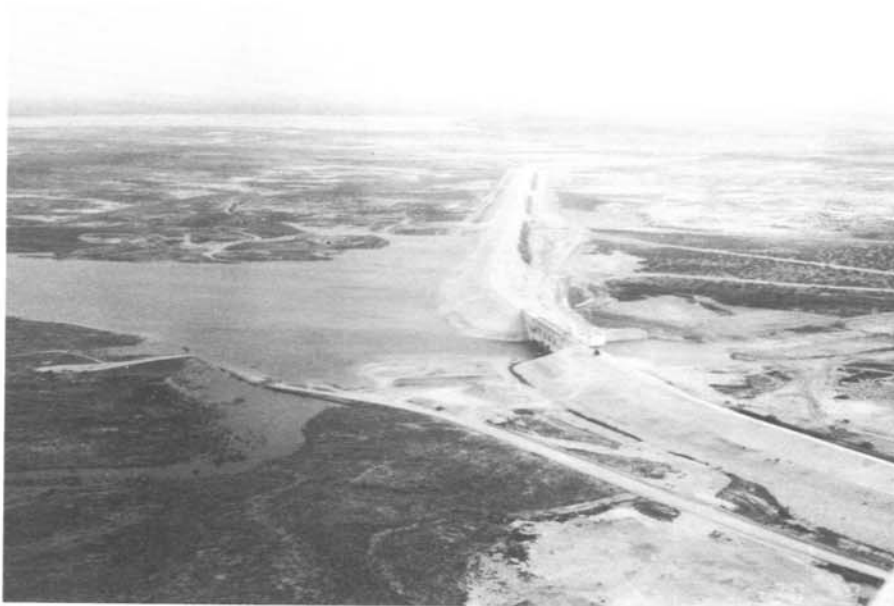
Figure 6. - Brantley Dam - Aerial view showing Dam and Reservoir. Lake McMillan can be seen in the background. Note curve of the earthen abutments. 9/29/88
